Technical Report CHL-98-22
July 1998

Three-Dimensional Breakwater Stability Tests at Vale de Cavaleiros, Cape Verde

by Ernest R. Smith, Jeffrey A. Melby

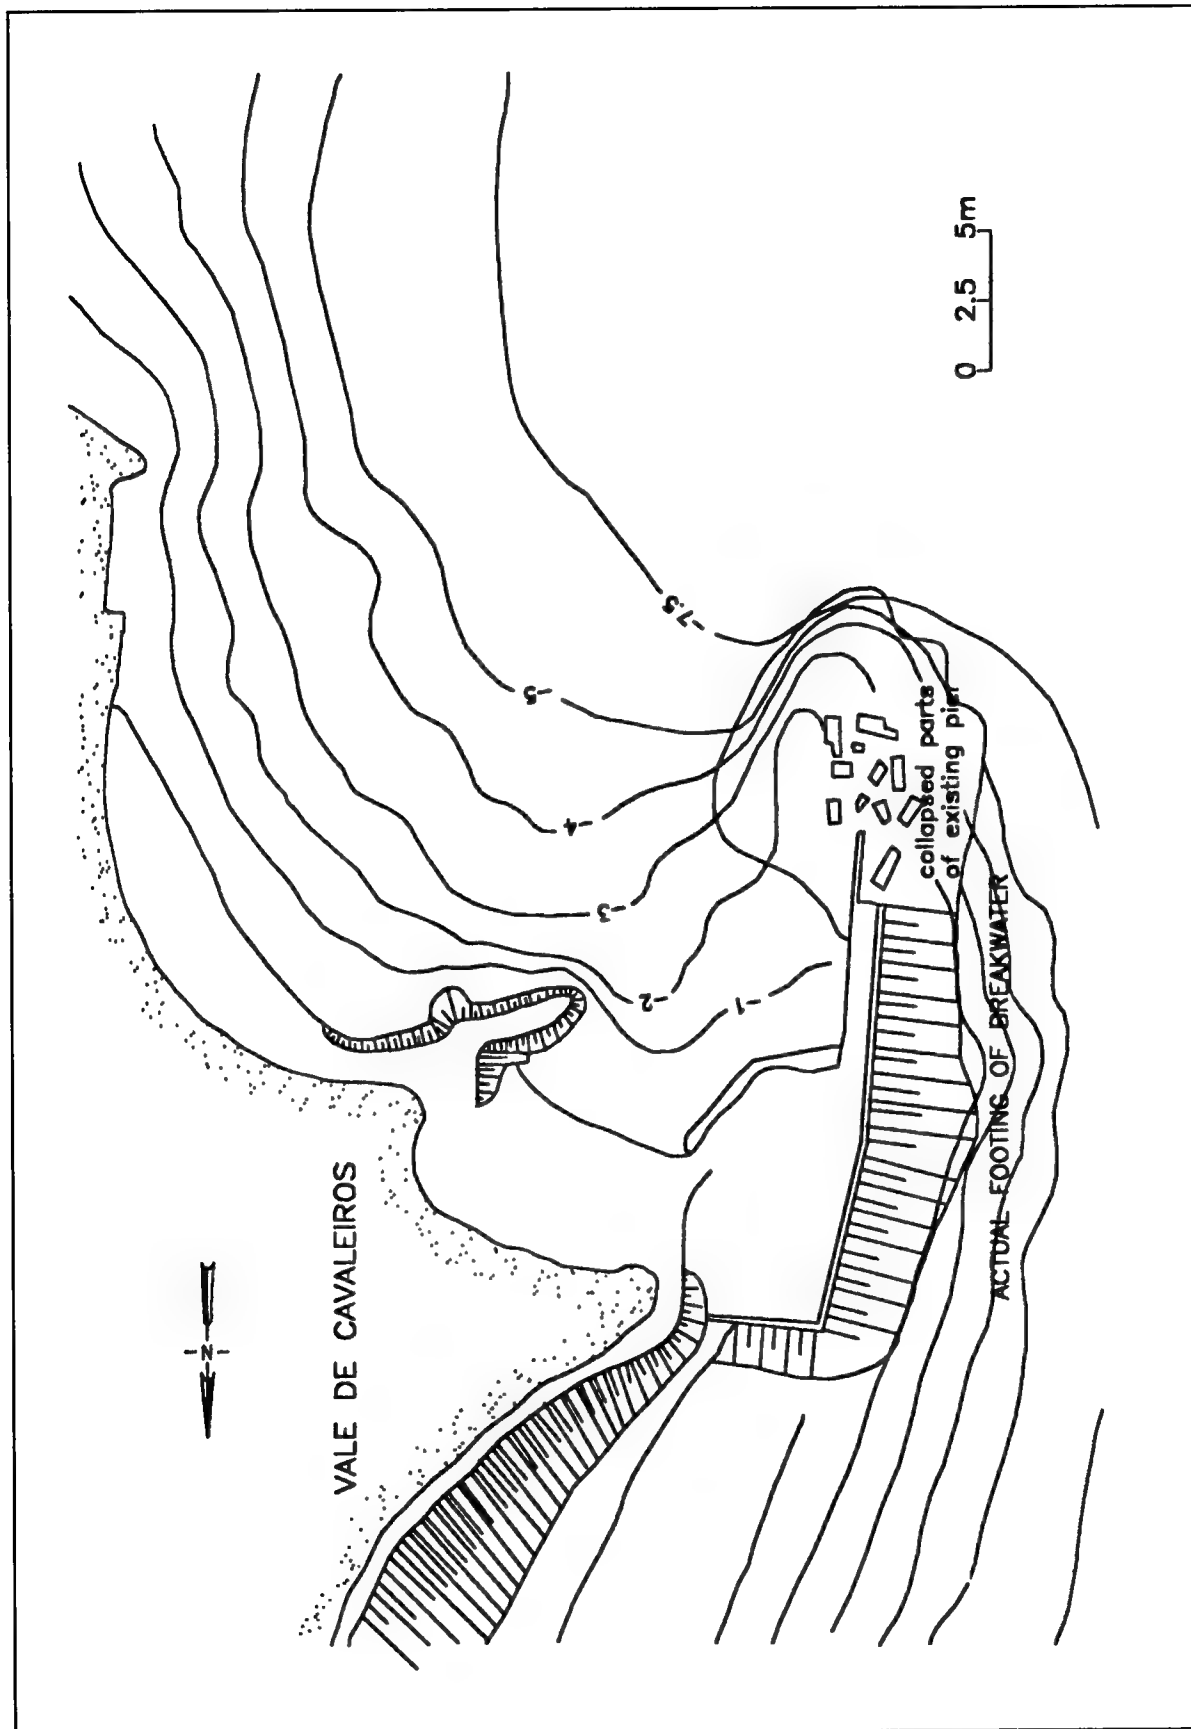
Figure 3. Existing site location map

The existing main breakwater is shown in Figures 3 and 4, with the layout view in Figure 4 dividing the breakwater into seven profiles. The porous breakwater consists of a traditional rubble mound fronting a recurved seawall. The crest elevation of the seawall is +8.15 m CD (CD refers to the lowest theoretical chart datum) while the crest elevation of the 6.25-tonne-tetrapod armor layer is approximately +7 m CD. The head of the breakwater was virtually destroyed by storms over 25 years and its remnants are completely submerged. The remaining tetrapod-armored trunk section extends south for approximately 180 m from Profile 1 (Figure 4). The existing tetrapod section extends down to approximately 0 m CD.

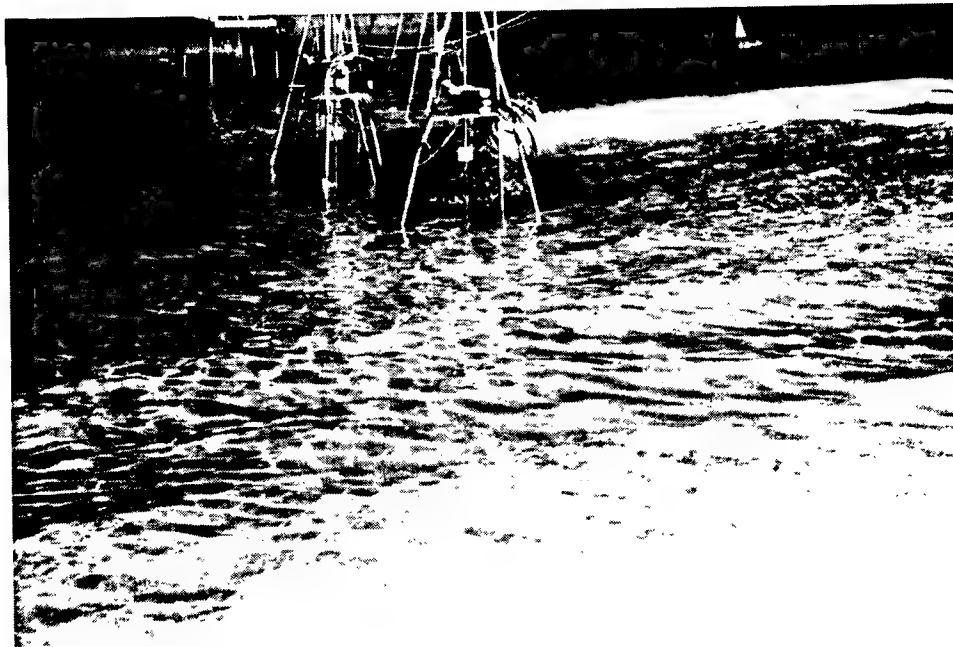
Figure 5. Three-dimensional stability model

Experiments were conducted in a 29.3-m-long, 29.6-m-wide, 1.5-m-deep wave basin. The model was constructed and molded of concrete to represent approximately 825 m of shoreline encompassing the harbor and breakwater location. Contours were molded to -20 m CD, and a 1V on 5H transition slope was molded from the -20-m contour to the model floor elevation of -21.3 m CD. Wave absorber was placed around the perimeter of the basin to minimize the effects of reflection. A photograph of the model is shown in Figure 5.

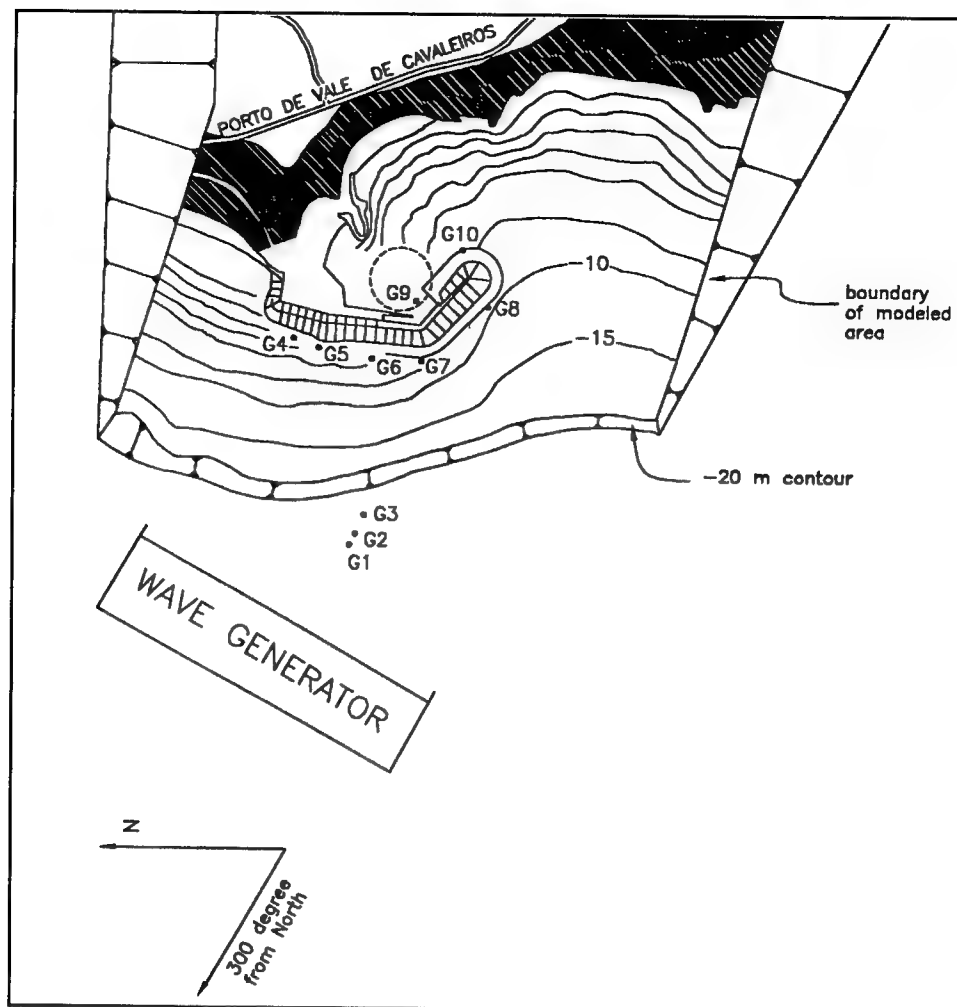
Figure 6. Three-dimensional model boundaries and wave gauge locations

calculation of incident and reflected wave heights by Goda and Suzuki (1976). The remaining gauges were placed at locations around the breakwater shown in Figure 6. Data obtained from the gauges were analyzed using the Time Series Analysis (TSA) computer program of Long and Ward (1987). Operations performed on wave data from individual gauges were mean down-crossing analysis to obtain significant wave height H_s , maximum and average wave heights, significant and average wave periods, and mean water levels at each gauge. Operations performed on the wave gauge array were unidirectional spectral density incident/reflection analysis to determine peak wave period T_p , and incident and reflected wave heights at the gauge array. Following calibration of the basin, Gauges 4 and 5 were removed and used in locations 9 and 10 during stability tests.

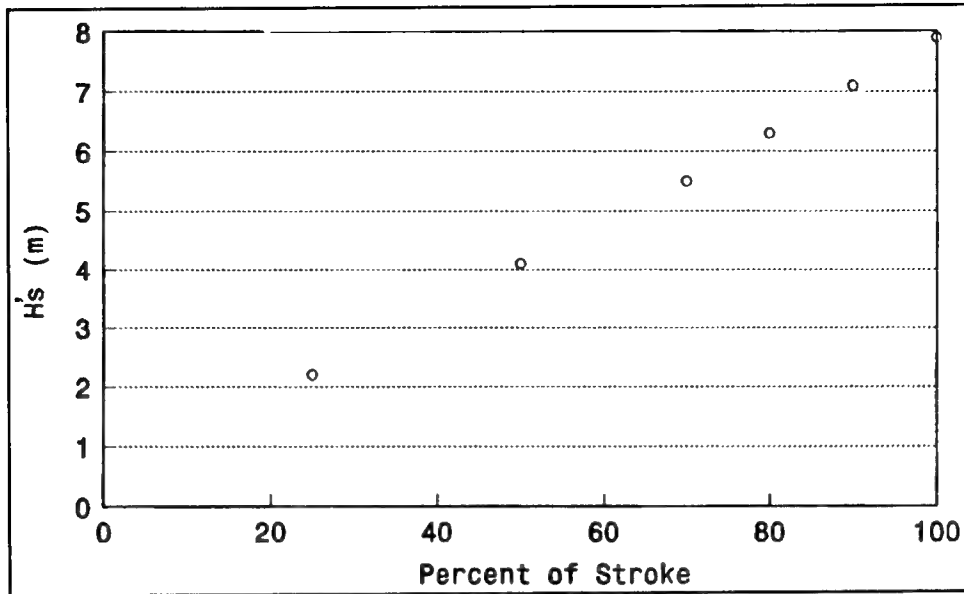
Figure 7. H'_s at -21.3 m CD versus generator stroke, 13-sec waves

Incident significant wave height H_s obtained from Gauges 1 through 3 during calibration is plotted versus percent of generator stroke in Figures 7 through 9.

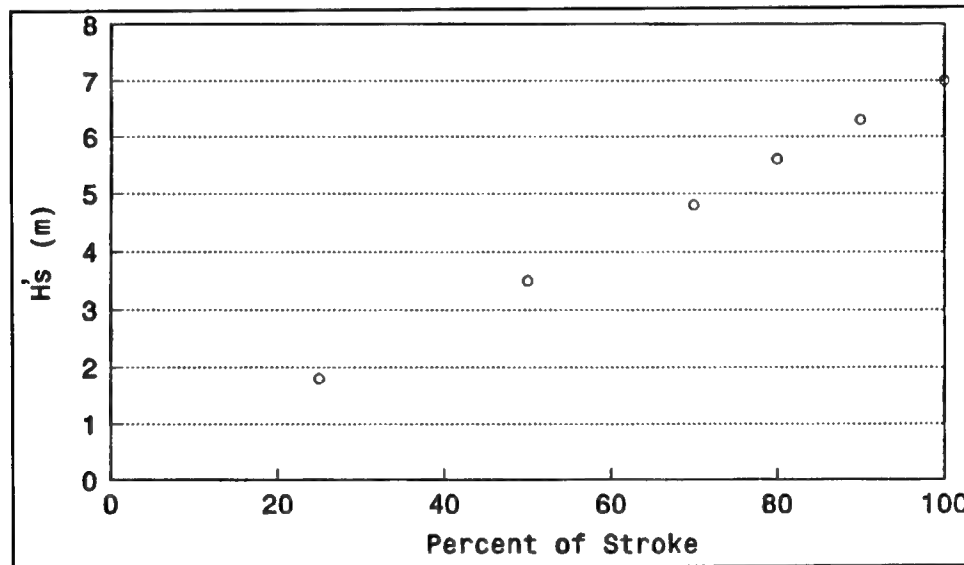
Figure 8. H'_s at -21.3 m CD versus generator stroke, 16-sec waves

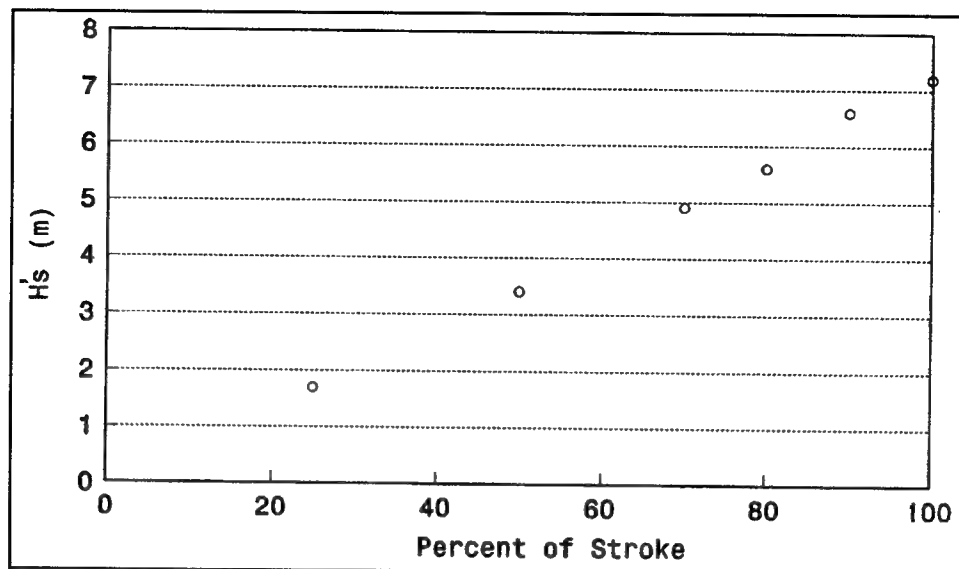
Figure 9. H_s' at -21.3 m CD versus generator stroke, 19-sec waves

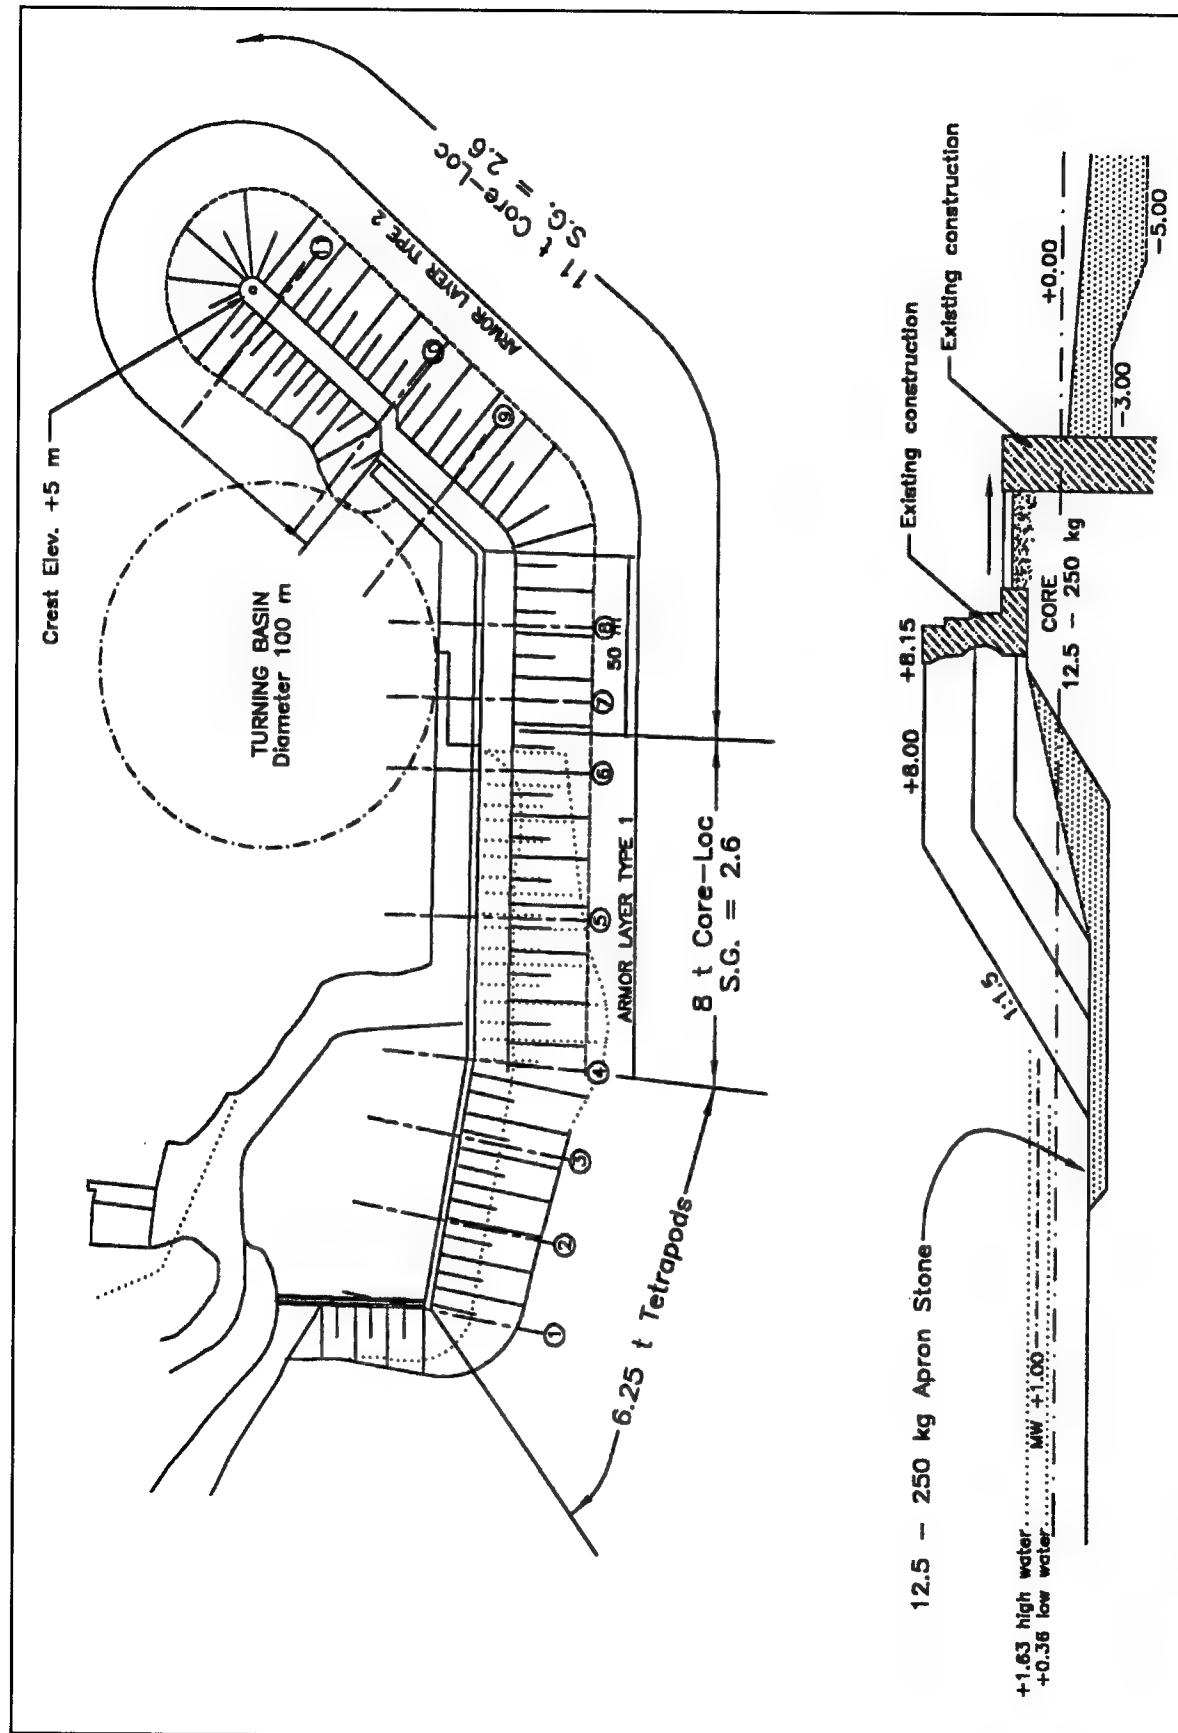
Figure 10. Elements of plan 1

Plan 1, the initial plan (Figure 10, Photos A1 through A3), consisted of 6.25-tonne tetrapods from the shoreward end of the breakwater to Profile 4; 8-tonne Core-Locs from Profile 4 to a point between Profiles 6 and 7 (a total reach of approximately 92 m); and 11-tonne Core-Locs on the remainder of the seaward trunk, around the head and terminating at the quay wall on the leeward side of the structure. For this plan, packing densities of the 8- and 11-tonne Core-Loc reaches were 0.55 and 0.59, respectively. The crest elevation of the head section was +5 m CD. Plan 1 was subjected to “shakedown” waves (13 sec, 3 m) to settle and nestle the armor units. During the wave series, apron material was displaced between Profiles 4 and 9, and Core-Locs were displaced at the toe near Profile 4 (Photos A4 through A6). The structure was subjected to 3.7-m waves for 13- and 16-sec periods, which caused additional toe unit displacement at Profile 4 and at the elbow near Profile 8.

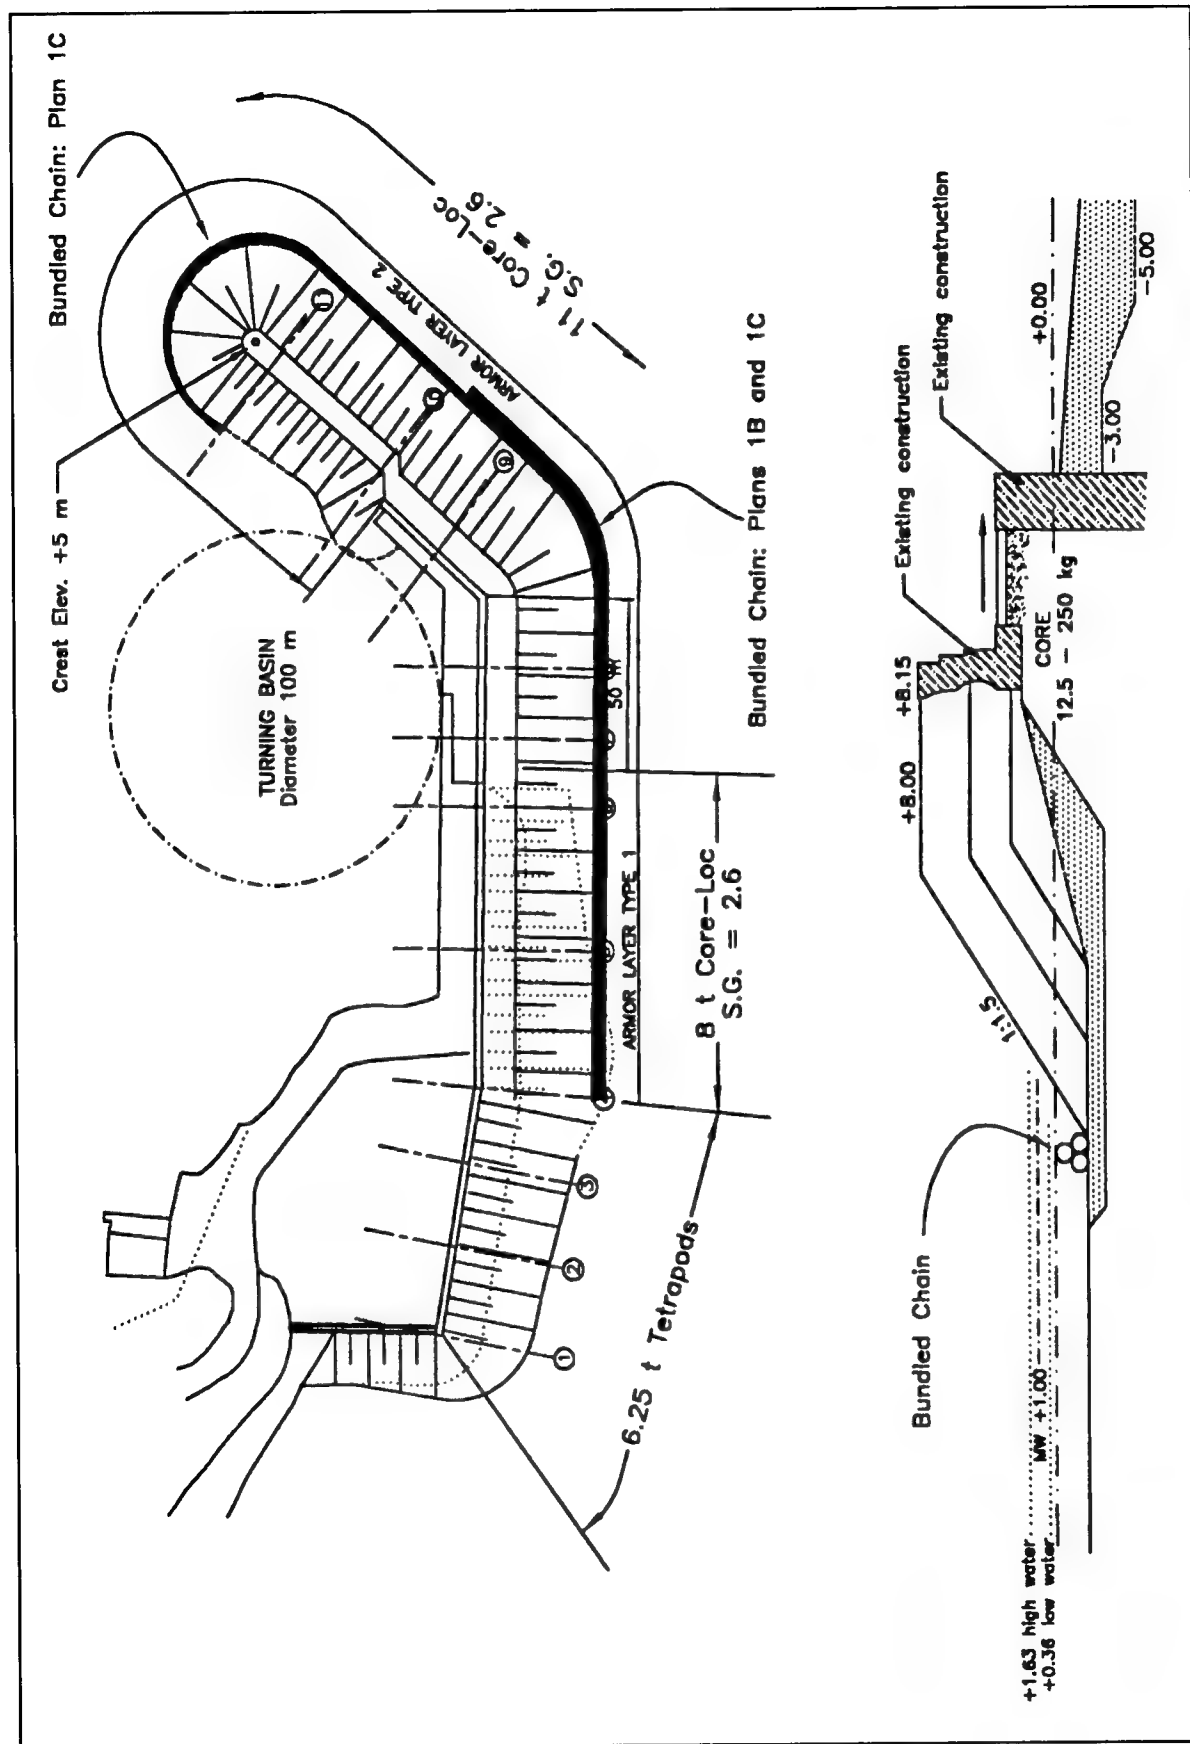
Figure 12. Elements of plans 1B and 1C

Plan 1B was identical to Plan 1 except three widths of bundled steel chain were placed along the toe from Profile 4 to the elbow (Figure 12). A single chain was placed at the toe at the elbow to the terminus of the quay wall. Additionally, a single chain was placed around the toe of the tetrapod section. The purpose of the chain was to stabilize the toe to observe the stability of upslope units. Rebuilding of the 8-tonne Core-Loc section resulted in $\phi = 0.60$. The addition of the chain stabilized the Core-Locs at the toe; however, wave energy also displaced the chain and it was necessary to reposition the chain between wave series. The armor layer loosened between Profiles 4 and 5, and apron material was displaced for wave conditions up to 17-sec, 5.2-m, but the section remained stable (Photo A13). During the 17-sec, 5.2-m condition, 11-tonne units at the toe near Profile 10, which was unprotected by the chain, were removed by waves, causing the upper units in this area to be displaced. A hole developed in the armor layer near the crown at Profile 10, which increased in size and migrated “north” along the structure (Photos A14 through A16). Additionally, green water overtopping was observed over the +5-m CD breakwater section for waves 3.7 m in height and greater. The severe breaking condition migrated to deeper water as peak period and/or wave height increased.

Plan 1C was the same as Plan 1B except three widths of steel chain were included along the toe from Profile 4 to the leeward side of Profile 11 for Plan 1C (Figure 12). In addition, the chain was anchored to the breakwater at approximately 8-m (prototype) intervals using pins inserted under the structure. The breakwater was rebuilt prior to experiments and the resulting packing densities for the 8- and 11-tonne Core-Locs were 0.62 and 0.59, respectively. The structure was stable for waves up to 6.7 m, but it was observed that the armor layer loosened in areas between chain anchors. During 16-sec, 6.7-m waves, one

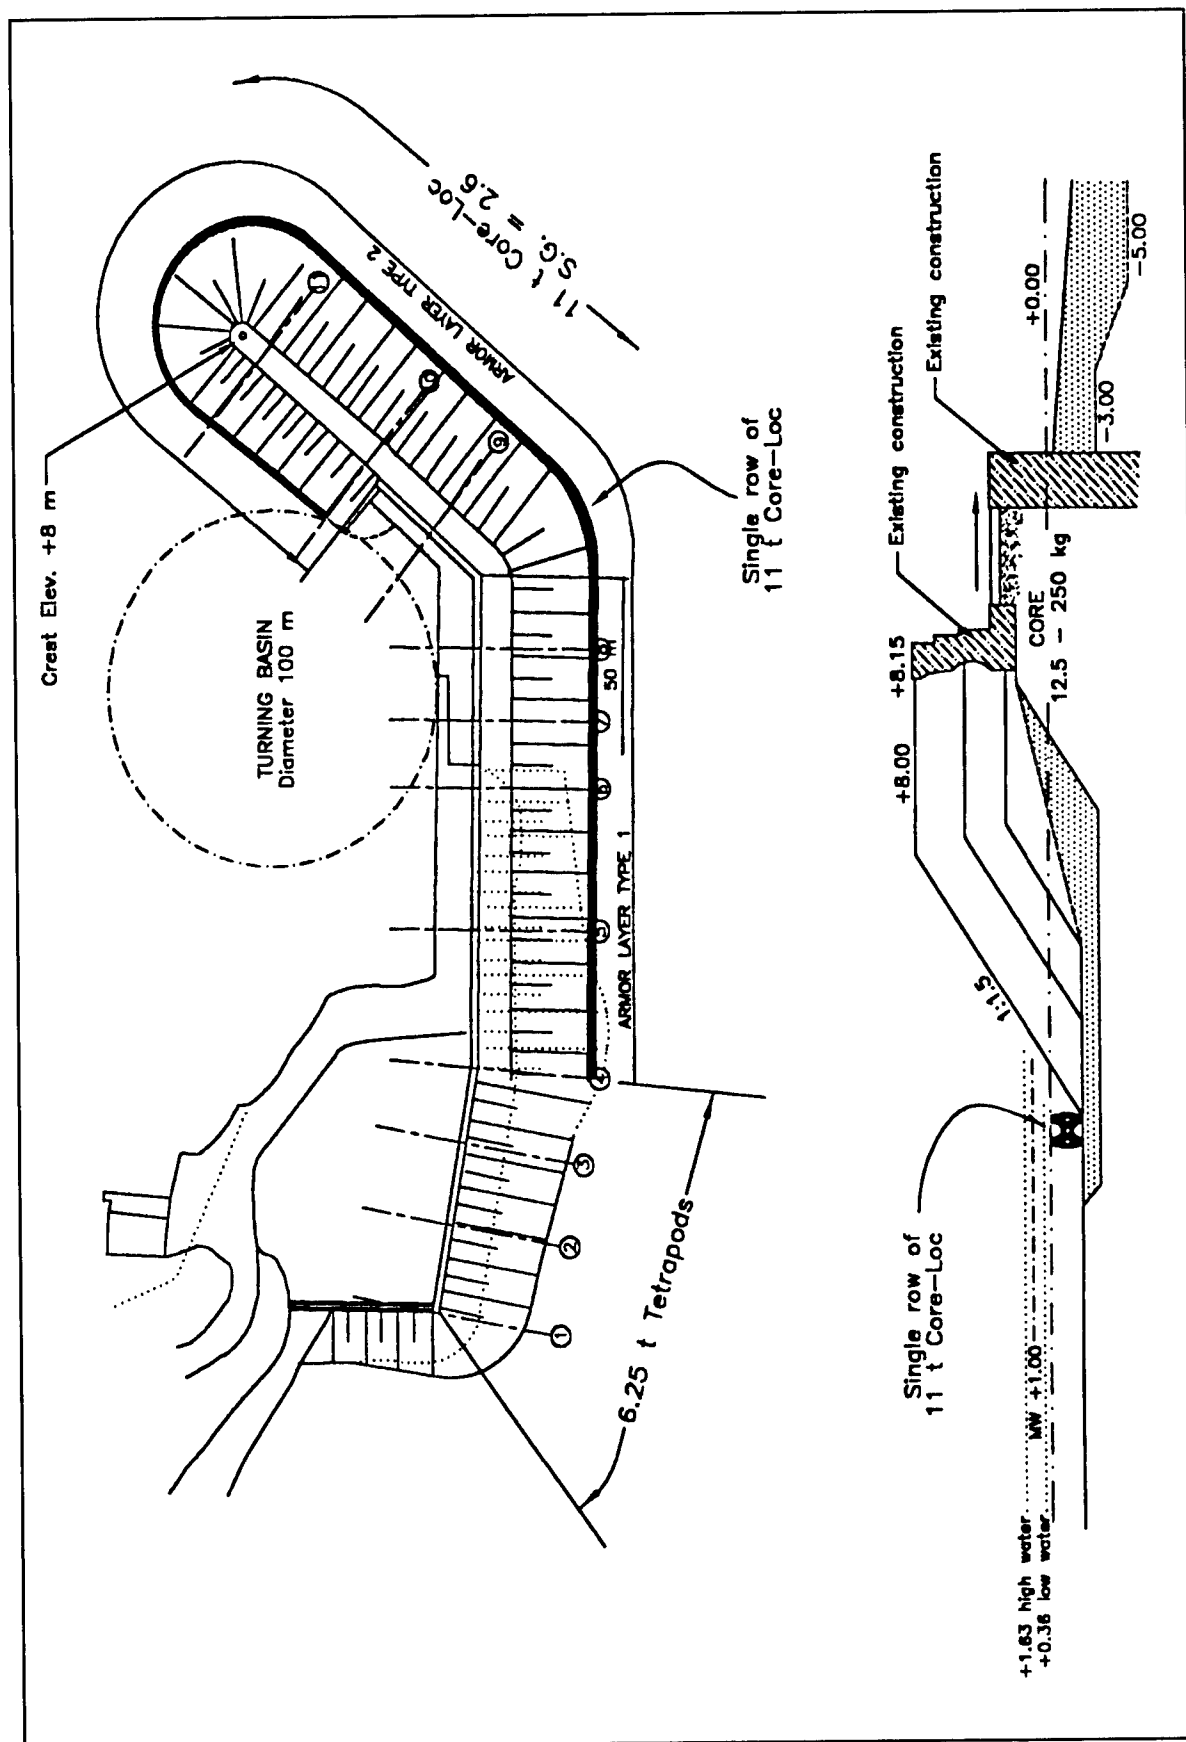
Figure 13. Elements of plan 2

Based on observations of the model and conversations with JV RRI-BCEOM personnel Messrs. A. Merrien and L. Fischer, Plan 2 consisted of raising the +5-m head portion of the breakwater to bring the entire structure to +8 m to reduce overtopping. The 8-tonne units were replaced with 11-tonne Core-Locs and the toe was reinforced with additional 11-tonne units placed in a single row (Figure 13). The packing density of the 11-tonne Core-Locs was 0.62. Toe protection units were placed 90 deg to the toe units of the structure in a manner in which adjacent units interlocked (Photos A23 through A25). The 11-tonne Core-Locs used for toe protection were displaced during 13- and 16-sec, 3.7-m waves, and the armor layer failed due to toe instability (Photos A26 and A27).

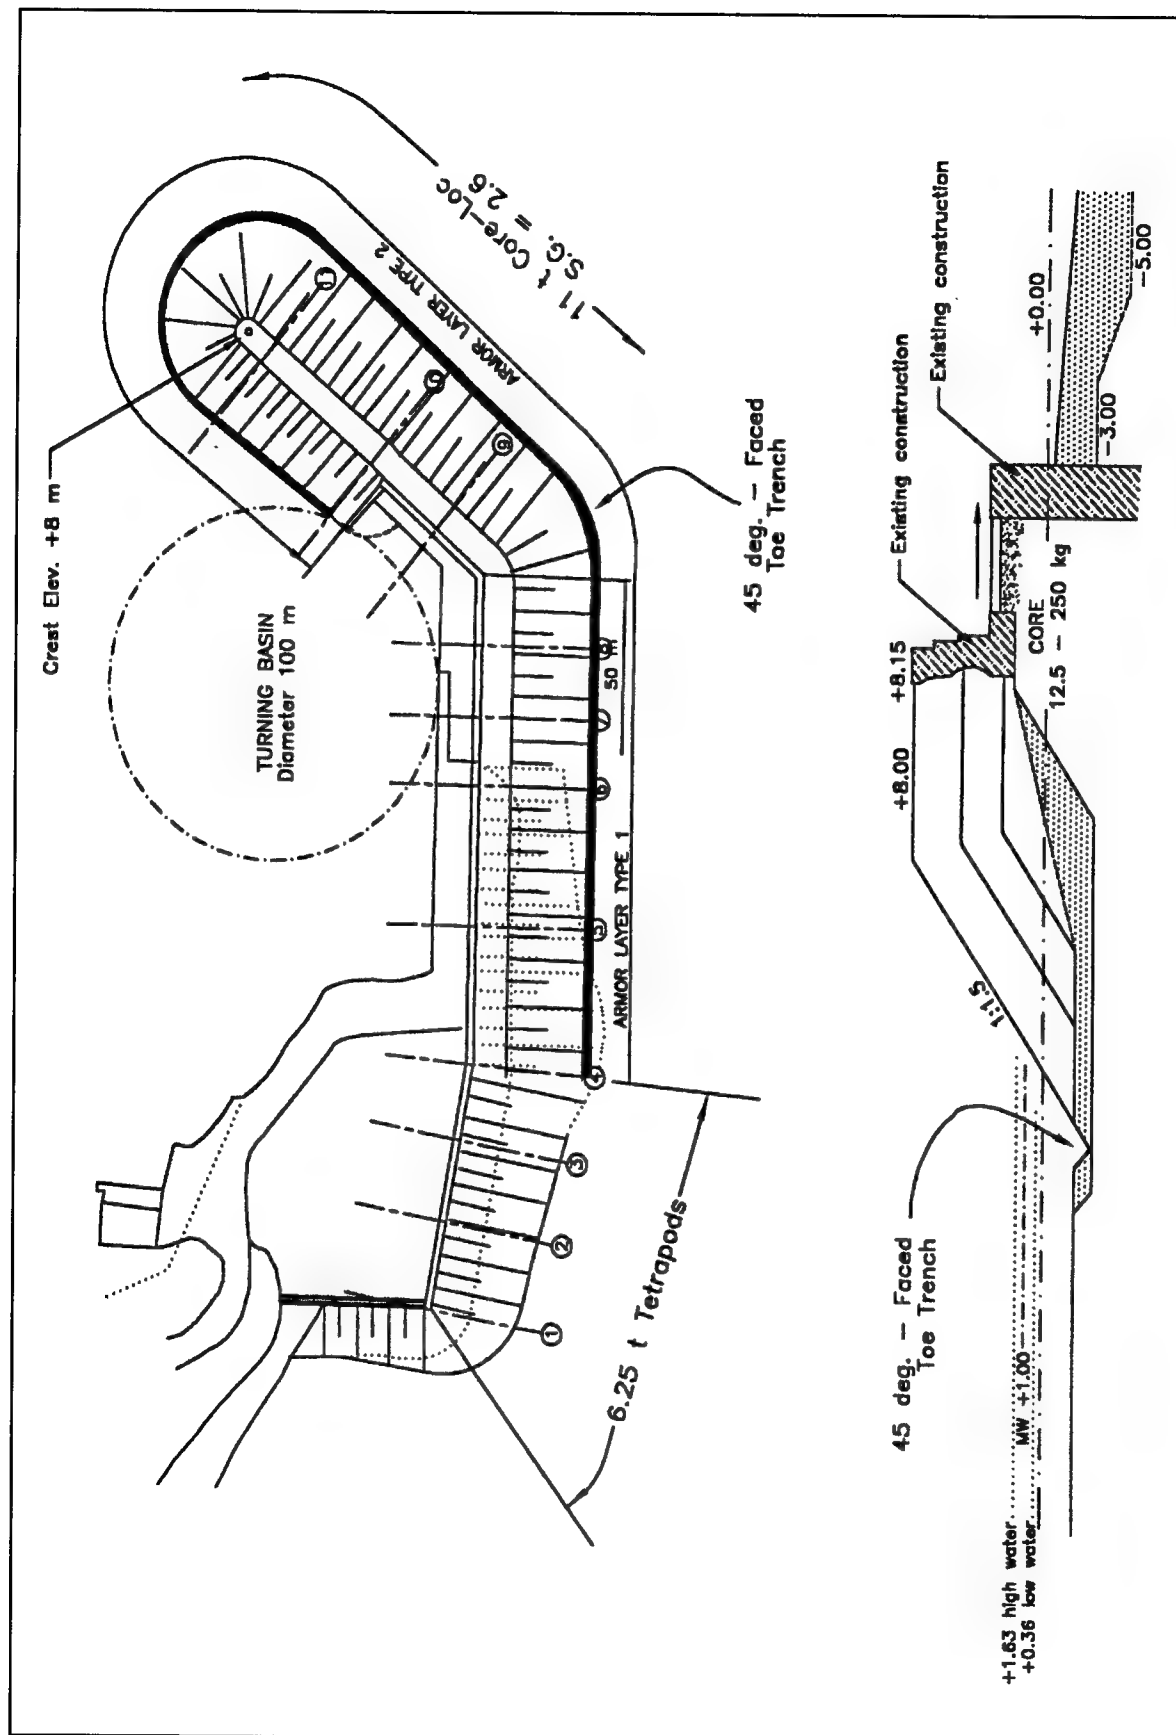
21 Figure 14. Elements of plan 2A

Plan 2A was the same as Plan 2 except the single row of 11-tonne Core-Locs was replaced with a wood board anchored to the floor around the entire Core-Loc armor layer to act as an immovable toe restraint. The board simulated a toe trench 1 m deep and included a 45-deg bevel adjacent to the toe unit (Figure 14). The plan consisted entirely of 11-tonne Core-Locs ($\phi = 0.61$) beginning at Profile 4 with a crest elevation of +8 m CD throughout the structure (Photos A28 through A30). One toe unit was displaced during 16-sec, 3.7-m waves near Profile 5, but the structure was stable for waves up to 16-sec, 5.2-m waves. During the 16-sec, 5.2-m condition, one toe unit was displaced near Profile 6, one toe unit was displaced from Profile 9, and three toe units were displaced near Profile 10. No further displacement of Core-Locs was observed for 19-sec, 5.2-m or 13-sec, 6.7-m waves; however, underlayer stone was observed to be displaced between Profiles 4 and 6 in areas of toe displacement. Additionally, the armor layer began to loosen in this area. During 16-sec, 6.7-m waves, 16 additional toe units were displaced, producing noticeable damage to the structure. Most of the armor was displaced off the structure at the elbow between Profiles 8 and 9 during 19-sec, 6.7-m waves (Photos A31 through A33).

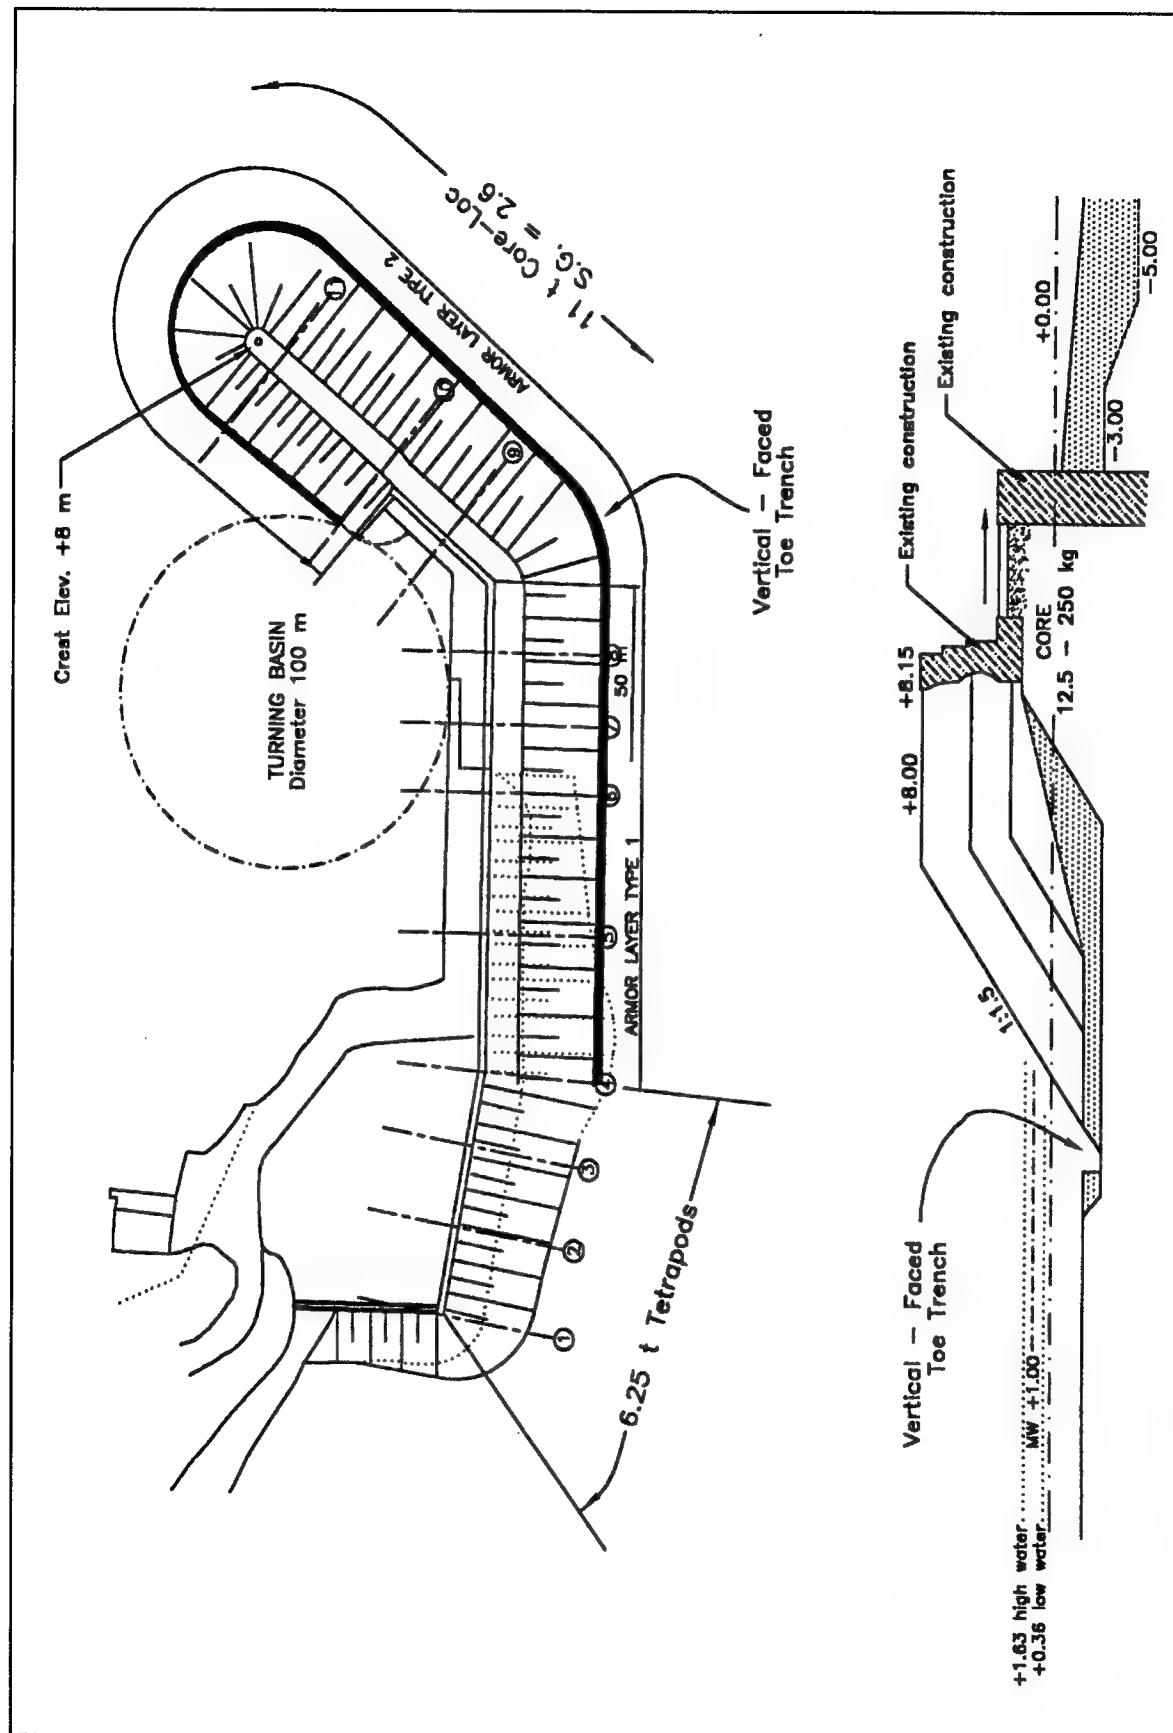
23 Figure 15. Elements of plan 2B

Plan 2B was identical to plan 2A except the toe reinforcement was constructed using a board anchored to the floor to represent a toe trench 1.5 m high with vertical sides (Figure 15). The breakwater armor was rebuilt and the packing density for the 11-tonne Core-Locs was 0.63. To expedite the study, all 3.7-m waves and the 13-sec, 5.2-m condition were omitted for this test series. From previous experiments with plans which included a restrained toe, the omitted wave conditions caused no or only minor damage to the breakwater. No units were displaced during this series (Photos A34 through A36). Plan 2B was rebuilt with the same packing density and the experiment was repeated. One Core-Loc was displaced off the head midway through 19-sec, 6.7-m waves, but the structure remained stable throughout the rest of the wave condition.

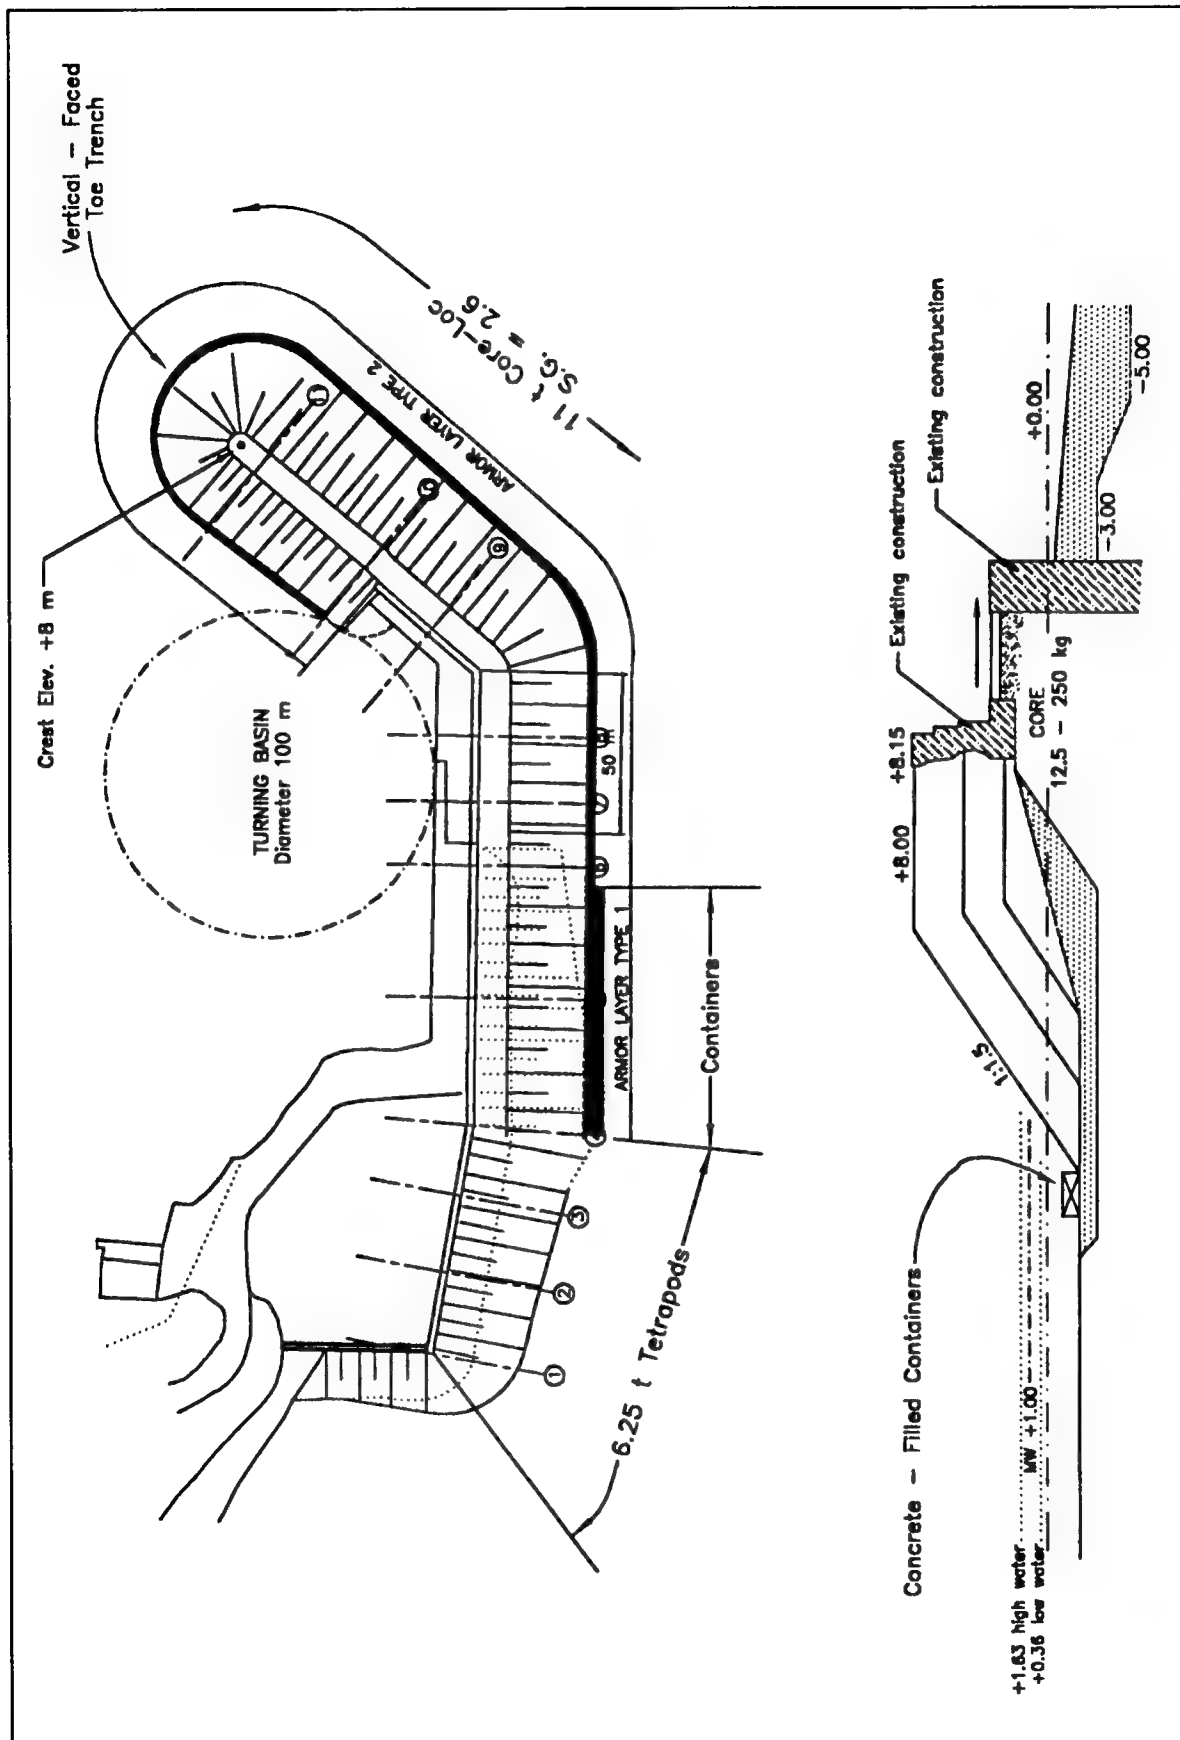
Figure 16. Elements of plans 2C and 2D

Plan 2D was identical to Plan 2C except the cargo containers were placed end to end along the Core-Loc toe (Figure 16, Photos A43 and A44). The armor layer was rebuilt with a packing density of 0.62. Results were similar to experiments with Plan 2C; the containers began to displace during 13-sec, 3.0-m waves and movement continued with higher waves. Eventually, all containers were displaced from their original position and moved southward along the breakwater. Without toe protection, Core-Loc toe units were displaced and upslope

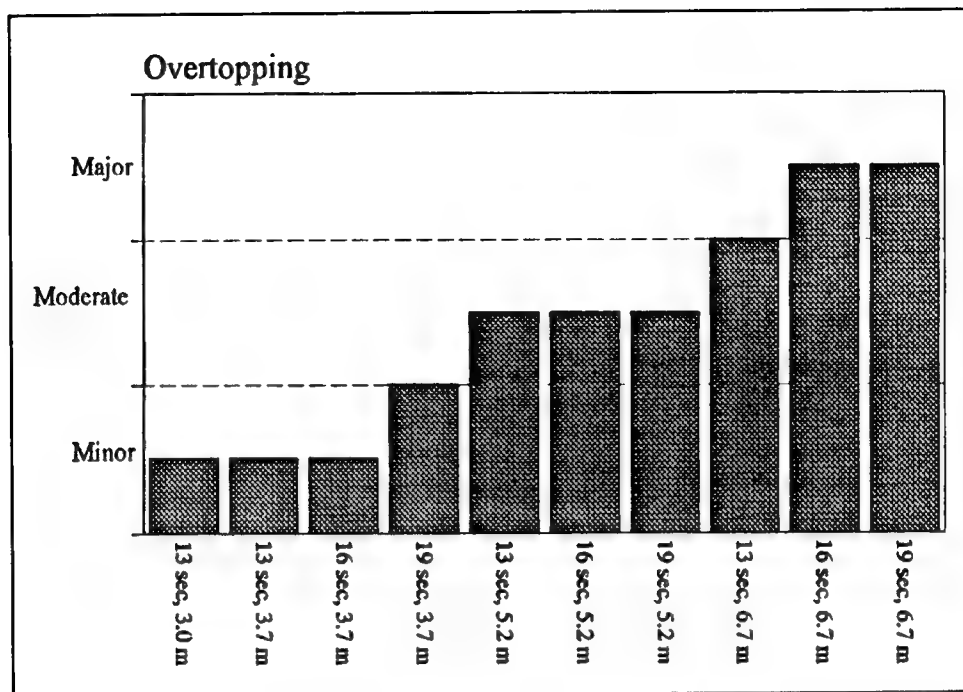
Figure 17. Wave overtopping at trunk, all plans

The classification of overtopping (minor, moderate, or major) is plotted versus wave condition in Figures 17 through 19. The wave conditions in the figures are labeled from left to right by the sequence in which they were generated during the experiment, i.e., 13-sec, 3.0-m waves were generated first and 19-sec, 6.7-m waves were generated last. Figure 17 shows the amount of overtopping that occurred at the trunk for all plans. Major overtopping occurred at the trunk for 16-sec, 6.7-m waves, but was minor or moderate for all other conditions. Figures 18 and 19 show overtopping classifications for Plan 1 and Plan 2 series experiments at the head, respectively. The figures illustrate the reduction of overtopping by raising the crest elevation to +8 m CD (Plan 2 series) from +5 m CD (Plan 1 series).

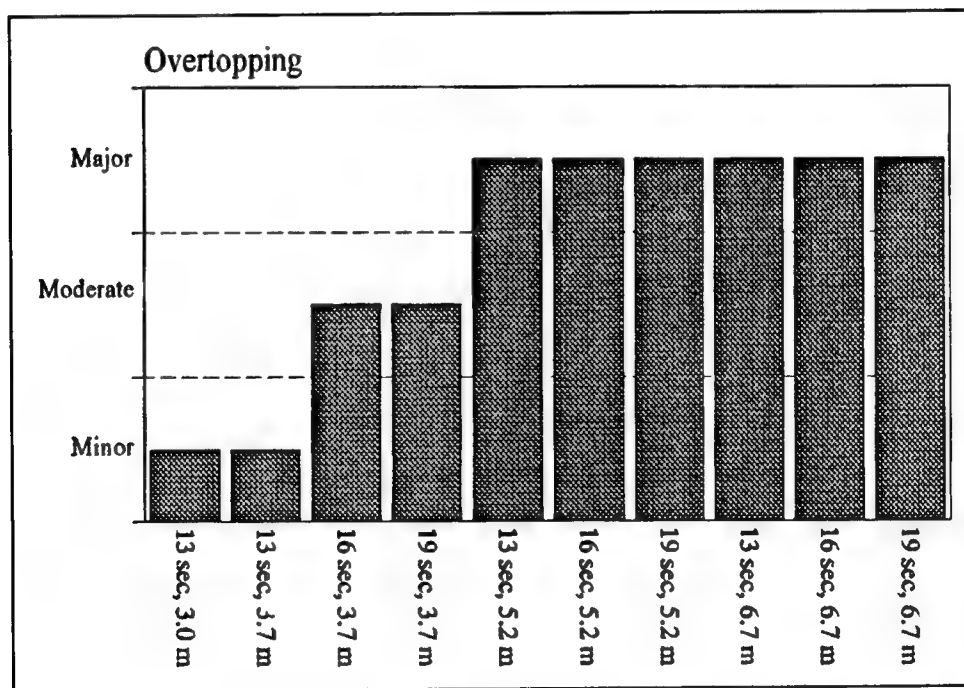
Figure 18. Wave overtopping at breakwater head, plan 1 series waves

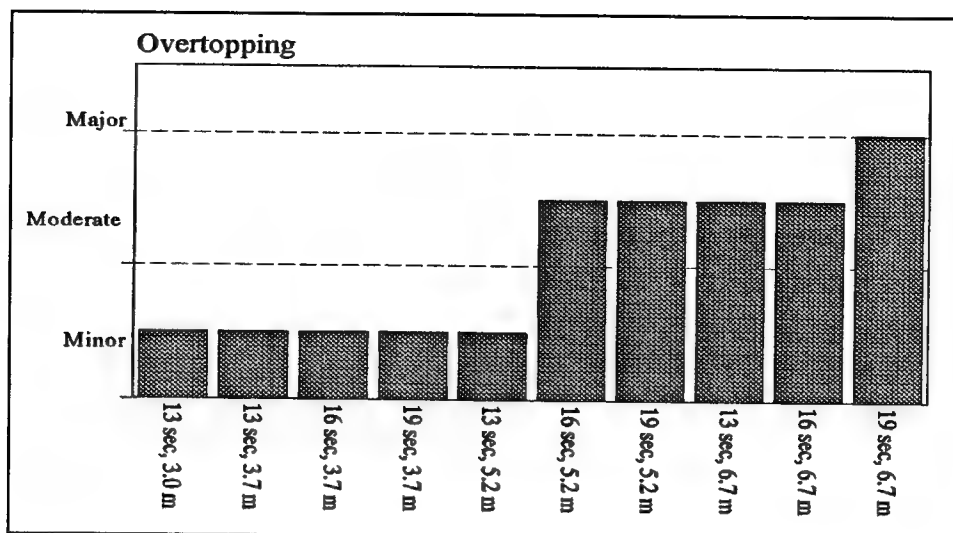
Figure 19. Wave overtopping at breakwater head, plan 2 series waves
